Type: Residential | Issue: AZ201301

Ram Jack Stabilizes
Unsupported Foundation
Caused by Severe Flooding

### UNSUPPORTED FOUNDATION

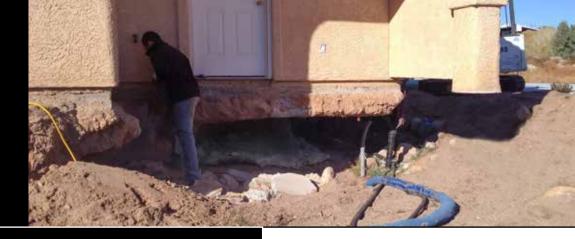
In Littlefield, Arizona, when a river overflowed its banks and flooded the area, it eroded away soil beneath the residence. The flood waters washed away so much soil the front corner of the home was hanging in the air with no structural support beneath it. The owner of the home acquired a large beam to temporarily add support to the structure, but he needed a permanent solution. The owner called Ram Jack Utah to take care of the problem.

The experts at Ram Jack Utah proposed an alternate solution that would both fill the empty space perfectly while providing the structural support the front corner of the home needed. Ram Jack proposed using structural polyurethane foam rather than slurry to fill the void beneath the home's foundation. This provided numerous advantages, including being lighter in weight, requiring less time to install, costing less, and not requiring removal of the floor covers for installation. Ram Jack Utah also proposed using strategically placed steel helical piles in order to lift the structure to an even level.

The helical piles were installed using a rotary torque driver and a mini excavator. After the first corner pile was placed, the temporary wood support beam was removed, and the rest of the piles were installed. Foam was installed throughout the process and allowed to cure as needed. When finished, the foam extended to the perimeter of the structure, occupying over 200 ft. Seven (7) 2 % in. helical piles with guide sleeves and low profile brackets were installed to an average depth of 25 ft., lifting the structure 1.5 in. for complete recovery.
