# CASE STUDY

## Beach Access for Condominiums

Otter Rock, OR

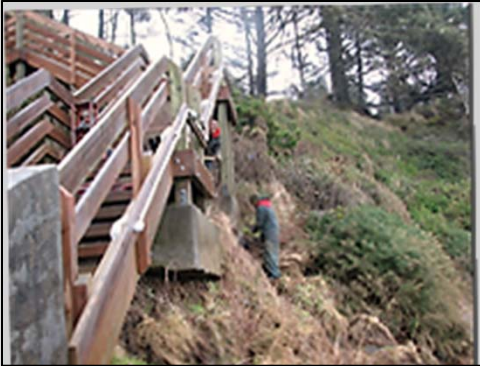
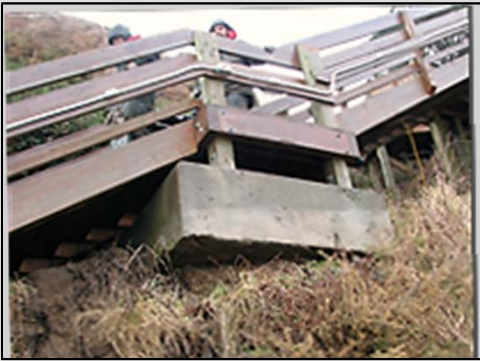
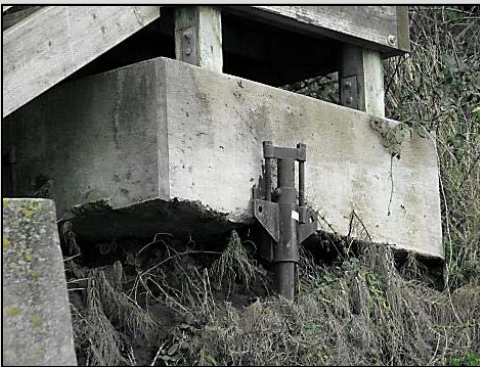
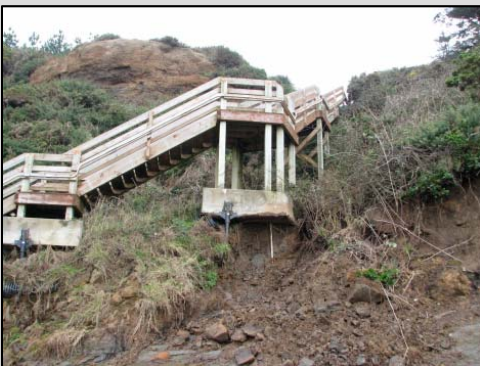
In December of 2009 Ram Jack of Oregon was contacted by a local contractor in Otter Rock, Oregon to stabilize concrete stair landings that allows beach access for condominium complex residents. The fear was that an ongoing erosion issue would potentially jeopardize the stair case's integrity, not allowing beach front access. The concrete stair landing had originally been constructed with another deep foundation system. However, there were concerns about the lateral stability of the existing foundation system as the potential of future erosion existed.

Ram Jack driven steel piles can be installed with hand carried hydraulics making it ideal for power and strength even in the tightest of working conditions. Ram Jack of Oregon was able to install four driven piles in a single day stabilizing the concrete landings. The bottom two pictures on the left were taken one year after Ram Jack driven piles were installed. As can be seen, the concerns of future erosion were accurate and the piles are performing as intended. When strength and stability are needed most, more engineers turn to Ram Jack.

Due to the steep incline and sensitive environment, the site did not allow for heavy equipment access. Because of this the project engineer originally specified galvanized pipe piles installed with an eighty-pound vibratory hammer. Ram Jack of Oregon suggested the use of Ram Jack's 2 7/8" diameter driven pile with an extended external sleeve to increase the pile's lateral strength even more. The project engineer found this to be a superior alternative to the vibratory piles due to the ability to install the piles to a higher load bearing capacity (20,000 lbs. ultimate).
