# CASE STUDY

Rio Chico Bridge

David, Panama

Installer: Ram Jack of Panama • Panama City • 507.237.2084

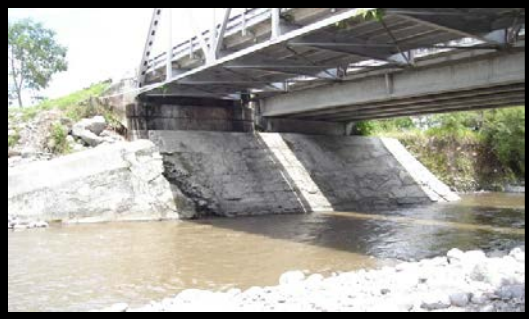
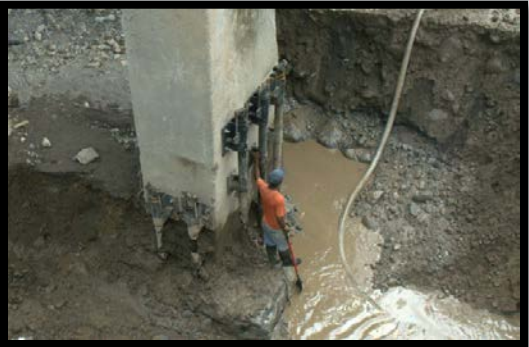
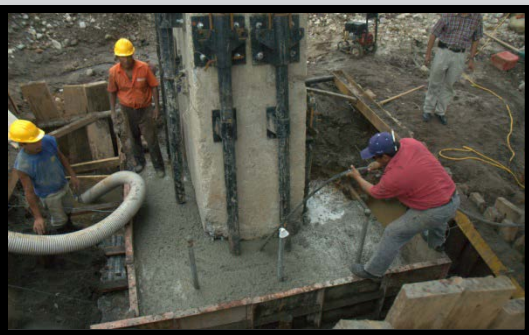
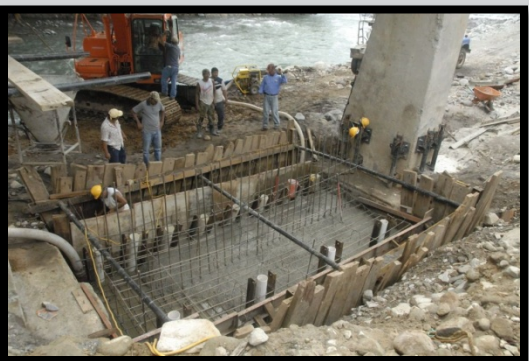
The Rio Chico Bridge, located on the main arterial road for Panama, had a column settle 4 ½ inches. The Rio Chico River has the fifth highest velocity in the world. It was imperative that piles were installed before rainy season. A couple of things that were tried were rerouting the river and adding a gravity wall to protect the bridge columns. However, water got behind the gravity wall which undermined one side of the gravity wall and approach. The bridge was forced to close. After exposing the footer, it was discovered that a large portion was missing.

Ten 3 ½ inch diameter piles were installed on the column. Access holes were cored through the existing footing, and the column was raised 4 ½ inches. Reinforcement was placed and epoxy grouted into the existing footer. Grout was also pumped into void space under the footer. The torsion cracks were generated from the settlement of the adjacent column.

Structural repairs were required. A mat foundation was placed connecting the two columns. Special brackets were designed and cast into the mat. Thirteen 3 ½ inch diameter piles were installed in the mat. Eight of these were battered.
