Type: Residential | Issue: SC201401

GEORGETOWN HOME STABILIZED

Georgetown, South Carolina

32 Helical Piles Used
to Secure Multiple
Areas of Structure

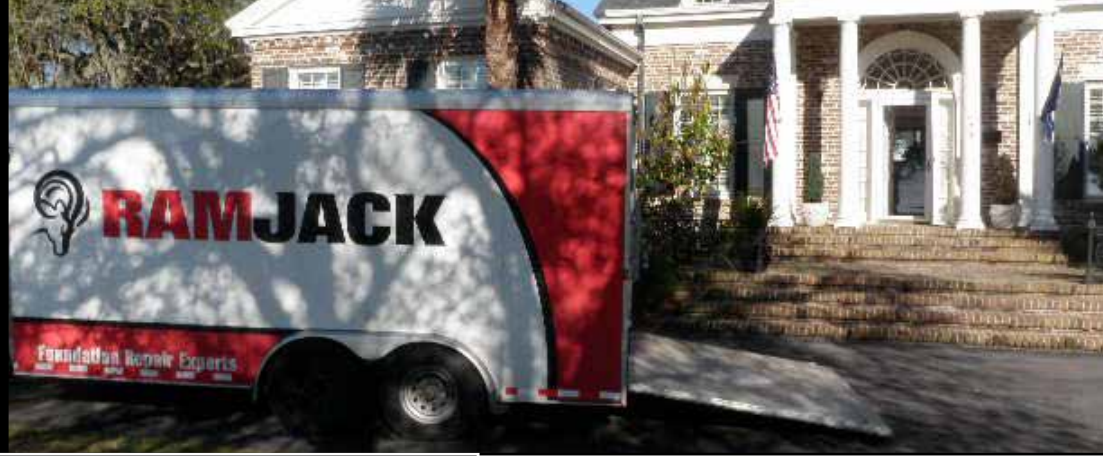
AFTER: Repaired concrete driveway

After evaluating the home, the Ram Jack specialist proposed using 32 Helical Exterior Piles to fix the home's foundation. Two piles would be used to stabilize the corner of the garage, with a third pile used to support the raised brick porch. Two more piles would support the raised garden, and another would reinforce the cracking column on the porch. Six piles would be needed to stabilize the garage, eight to support the columns through the concrete, and twelve to bolster the garage

through the concrete. The goal of the job was to stabilize the home and lift uneven areas.

Repairing this home proved to be a long, complicated job. The crew leader, along with his hard-working crew, drilled through concrete and had to deal with multiple feet of water in many of the holes. Though difficult, the job was successfully completed. In the end, 32 Helical Exterior Piles were installed to an average depth of 23.75 ft. The homeowner was extremely happy with the results, noting the quality of the work as well as the diligent and accommodating nature of the Ram Jack employees.

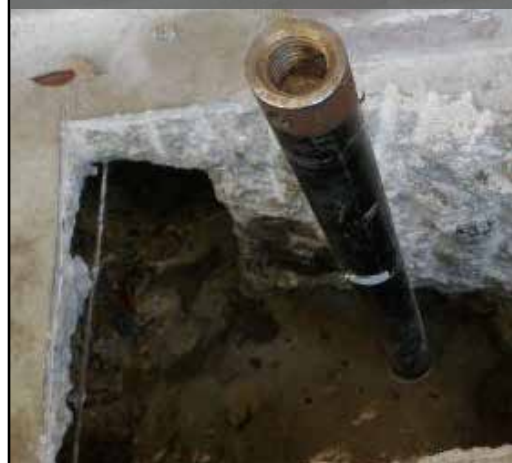
DURING: Helical pile installation
