2015 CASE STUDY

Helical Piles Strategically Placed to Stabilize Myrtle Beach Home

STABILIZATION OF MYRTLE BEACH HOME

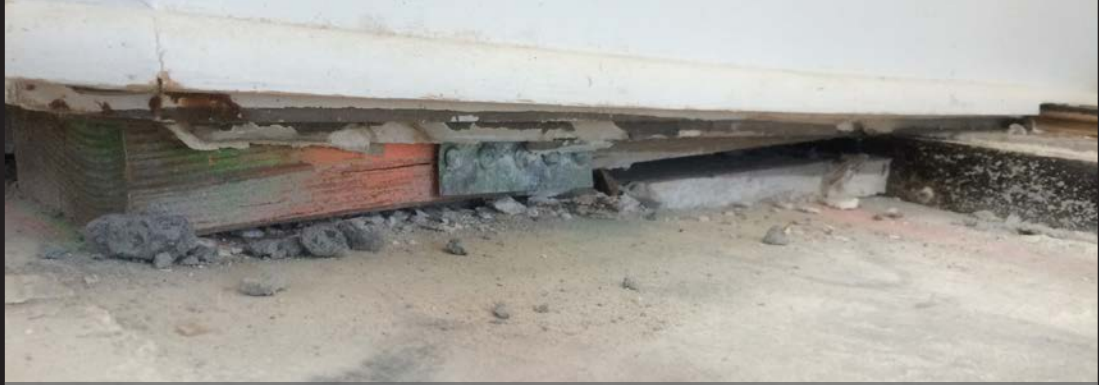
BEFORE: Foundation settlement caused floor separation

After a thorough inspection, Ram Jack South Carolina found significant foundation settlement in various areas of the home, most notably the entryway and kitchen. The floor was uneven and separating from the baseboards in some areas. Given how quickly the home's foundation settled relative to its age, Ram Jack South Carolina advised the owners to act quickly to prevent any further settlement and damage.

Over the course of two days, Ram Jack South Carolina installed (14) 2 3/8" helical piles to an average depth of 25 ft. These piles provided adequate lift and stabilization to maximize recovery for the home while preventing further settlement damage in the areas of installation. When the job was complete, the homeowner enthusiastically said, "Very good work crew. I am happy with the results at this point. Cleanup was excellent!"

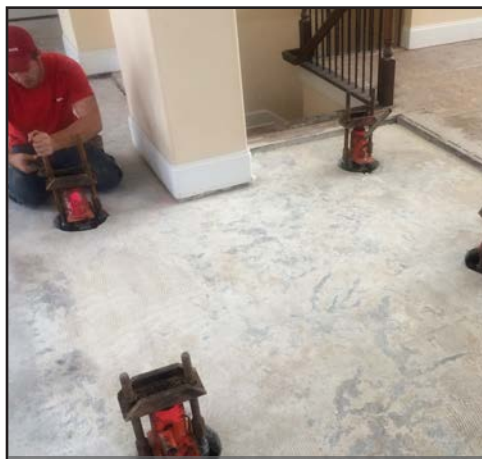
DURING: Installation of helical piles

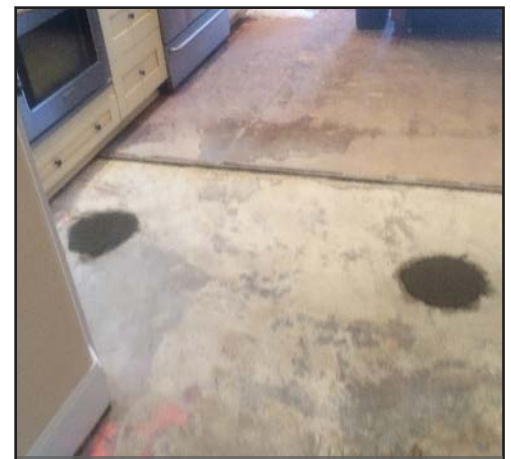
AFTER: Minimal disturbance to interior slab
