CASE STUDY

Timber Column Project

Galveston, TX

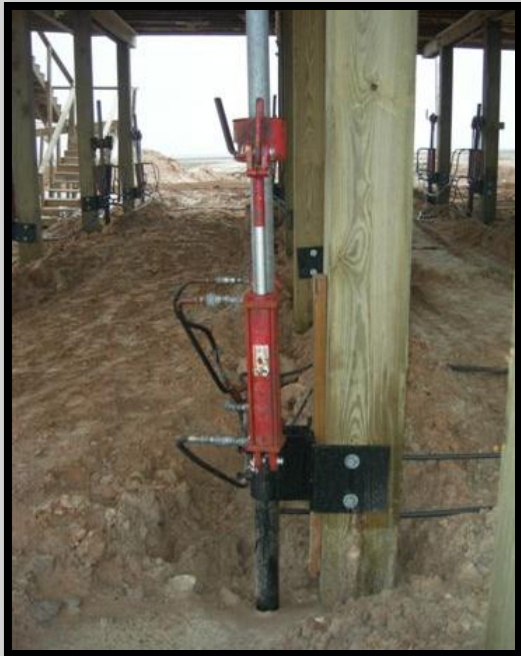
When hurricane Ike hit the shores of Texas, the island of Surfside and Galveston were on the western side of the storm. This is where the surge of water exited back into the ocean taking 5 to 6 feet of sand and dunes with it. The erosion caused catastrophic damage leveling most of the structures on the beach. However, some of the structures survived total collapse but had settled several feet. The home shown to the left had settled 3 to 6.5 feet from its original elevation. The structure had deflected 6 inches at the top of the timber piles.
